The
San Francisco Earthquake and Fire

A BRIEF HISTORY OF THE DISASTER

A Presentation of Facts and Resulting Phenomena, with Special
Reference to the Efficiency of Building Materials
Lessons of the Disaster

A. L. A. HIMMELWRIGHT, C.E.

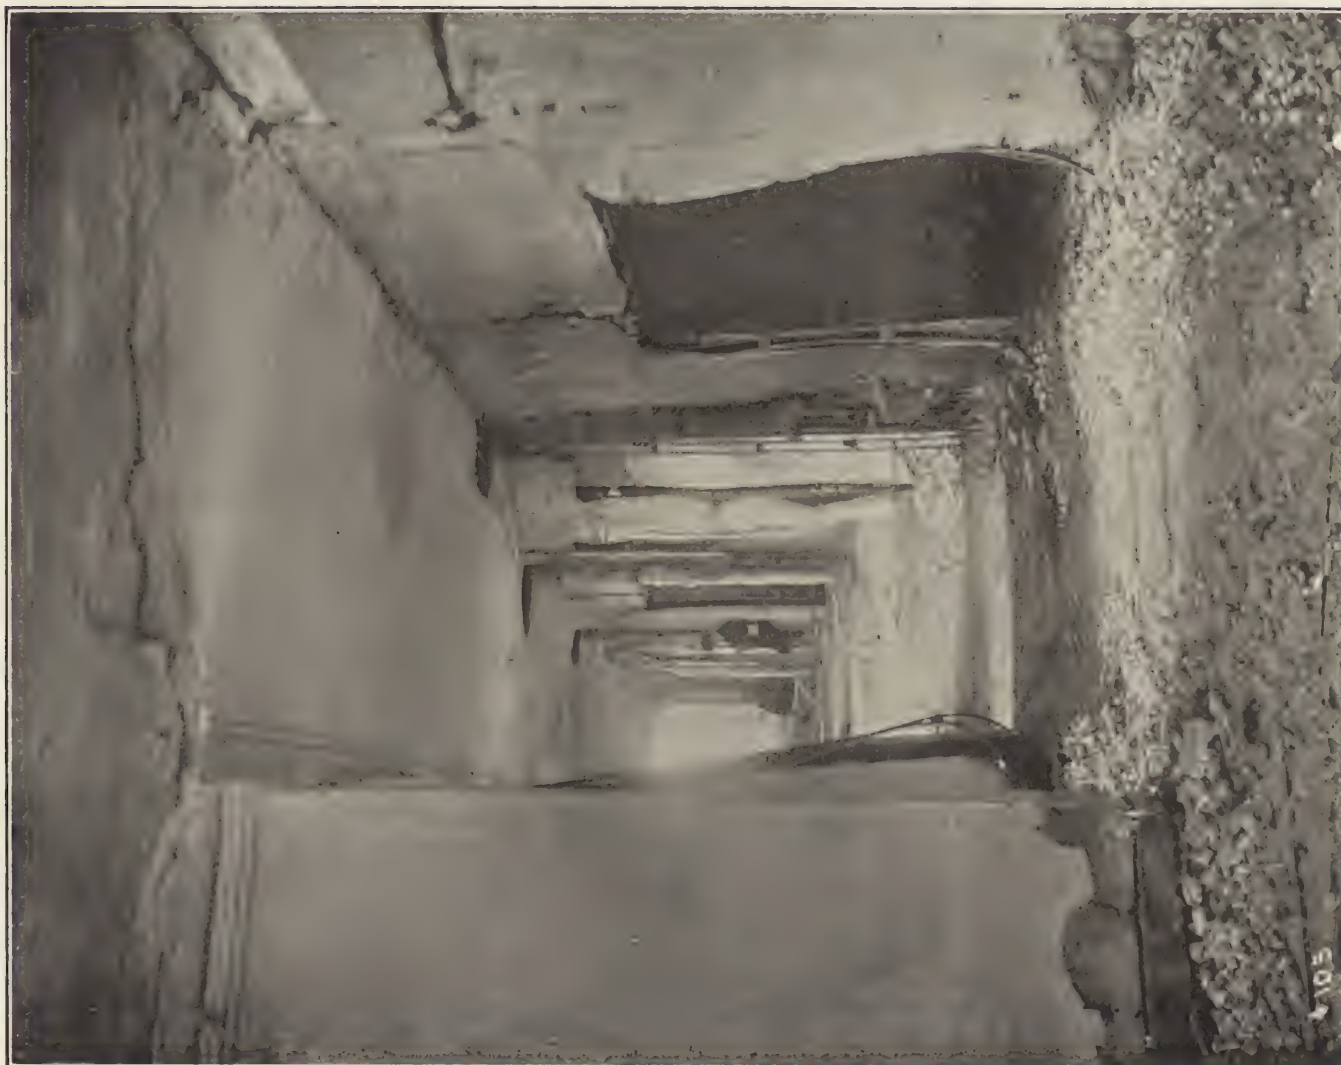
FAIRMONT HOTEL. Fifth Story looking down the corridor. This view is typical of the upper stories, and shows the distorted condition of the partitions and the warped surfaces of the floors, caused by the buckled columns in the lower stories. The man in the rear is standing in a depression, or low point, on the floor. The undulations of the floors can perhaps be best understood by following the intersection of the ceiling and partition at the right hand upper corner of the corridor. Only concrete floors and metal lath and plaster partitions would remain in position under such conditions.

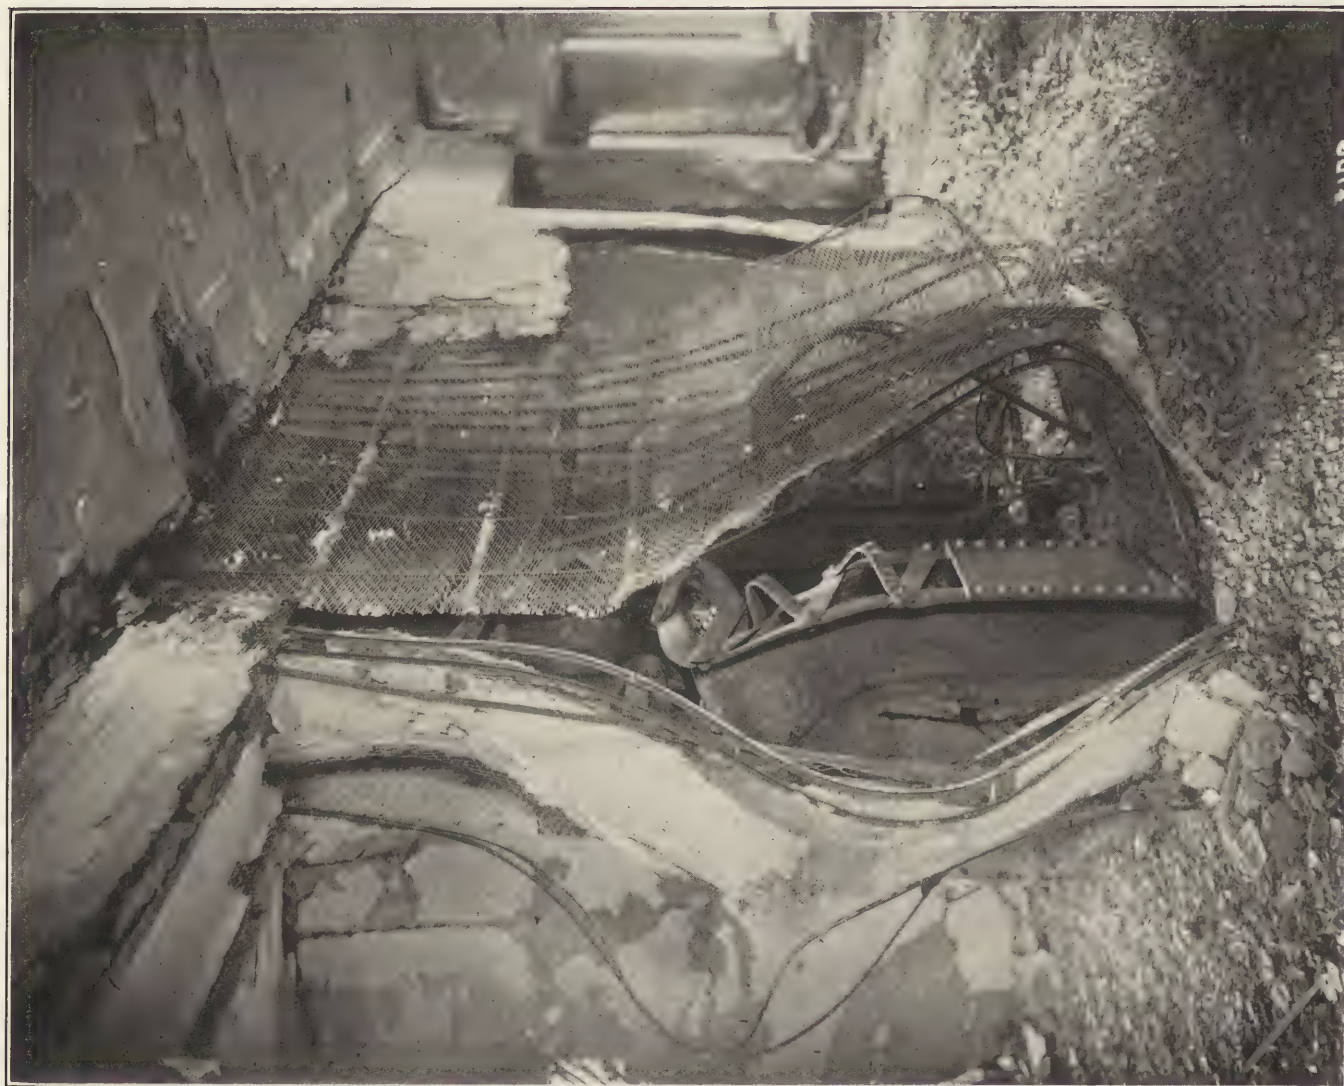
FAIRMONT HOTEL. Sixth Story. Showing a badly buckled column protected by partitions built around it. The protection should have been independent of the partitions and should have been anchored to the column by suitable light steel furring at 12 to 16" centres.

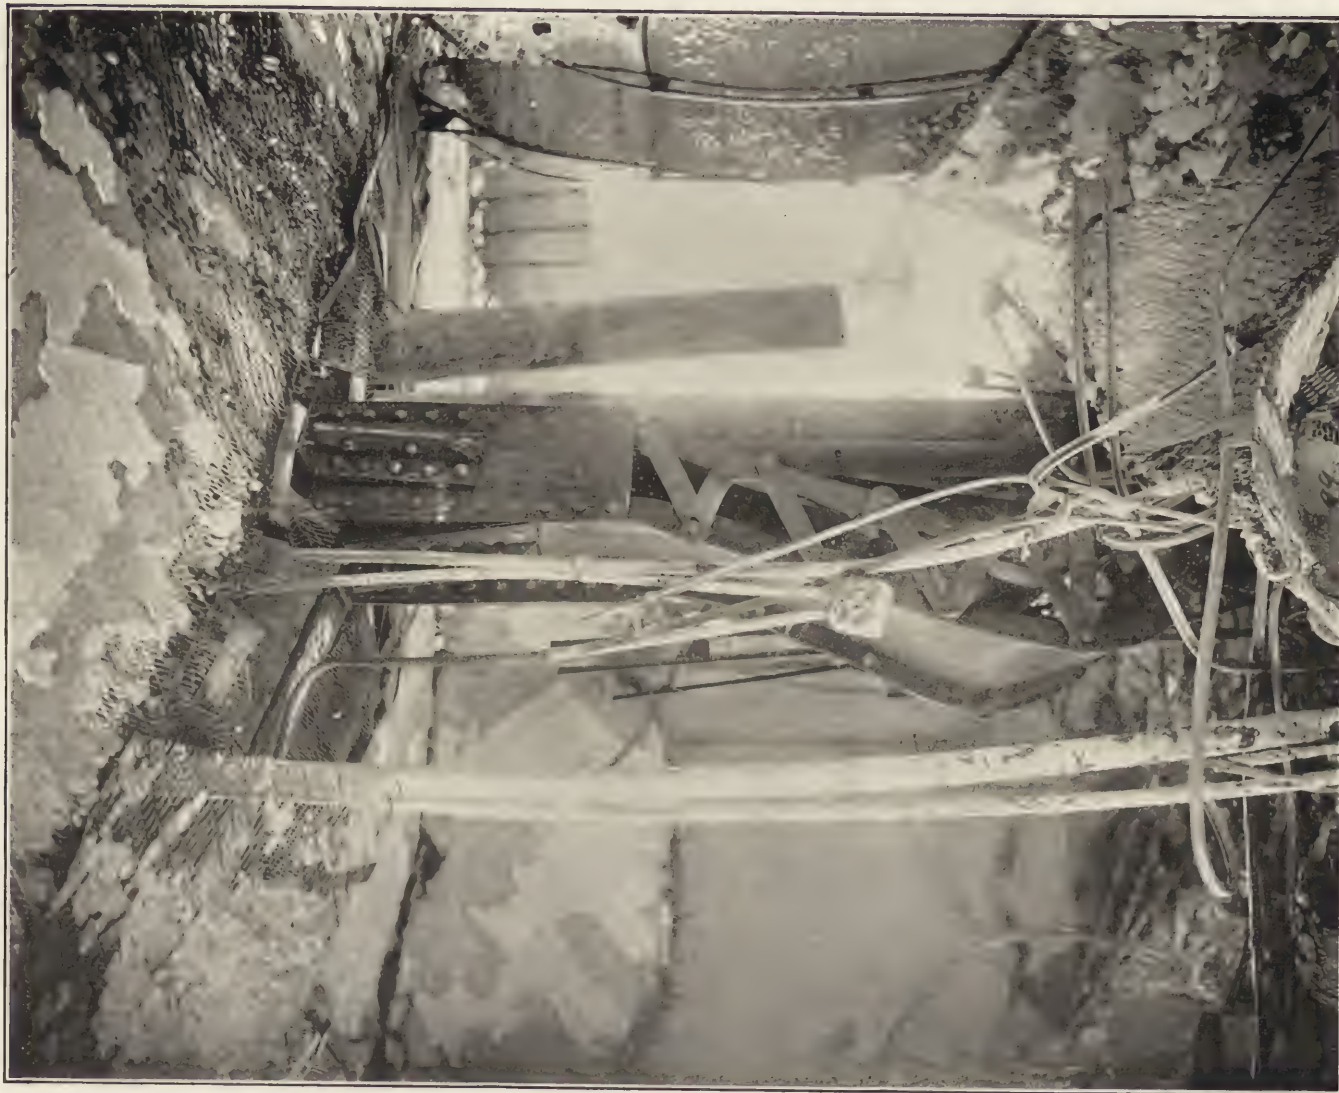
FAIRMONT HOTEL. Sixth Story. Showing a badly deflected and buckled column that was originally enclosed within expanded metal lath and plaster partitions, together with various pipes, etc. The bulging and distortion of the pipes no doubt contributed to the damage. At the ceiling level, the roof beams are still clinging to the column, although some of the rivets no doubt have been sheared. This distortion of the steel did not cause the concrete roof slab to fall out.

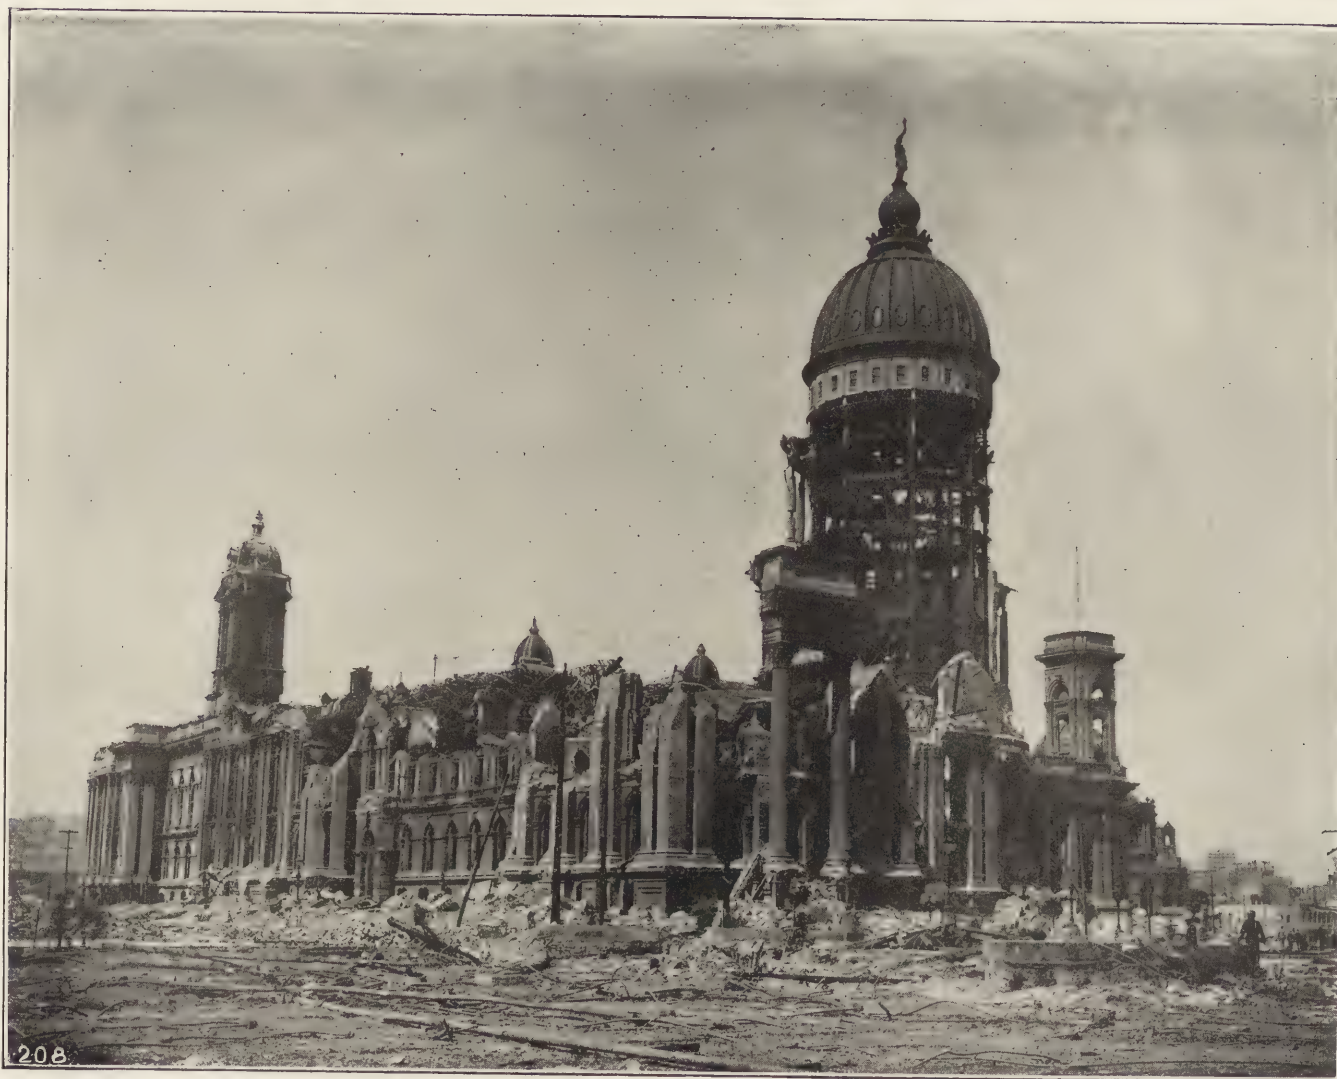
CITY HALL. McAllister, Larkin and Leavenworth Streets. This imposing structure covered a large triangular block, and was built by the city at an expense of \$7,000,000.00. Practically all the damage was wrought by the earthquake, and was due to poor workmanship and an inferior grade of lime mortar. Fire subsequently destroyed all that was combustible in the *débris*. The steel work is badly deflected and distorted owing to improper protection. The fire-proof floors were of stone concrete of poor quality on corrugated iron centres. Many of the floor arches have failed. The building is wrecked and will be a total loss. The Hall of Records, an annex to this building, the dome of which shows behind a secondary tower on the right-hand side, was but little damaged by the earthquake. The interior, however, was completely fire swept, leaving nothing but the shell remaining.

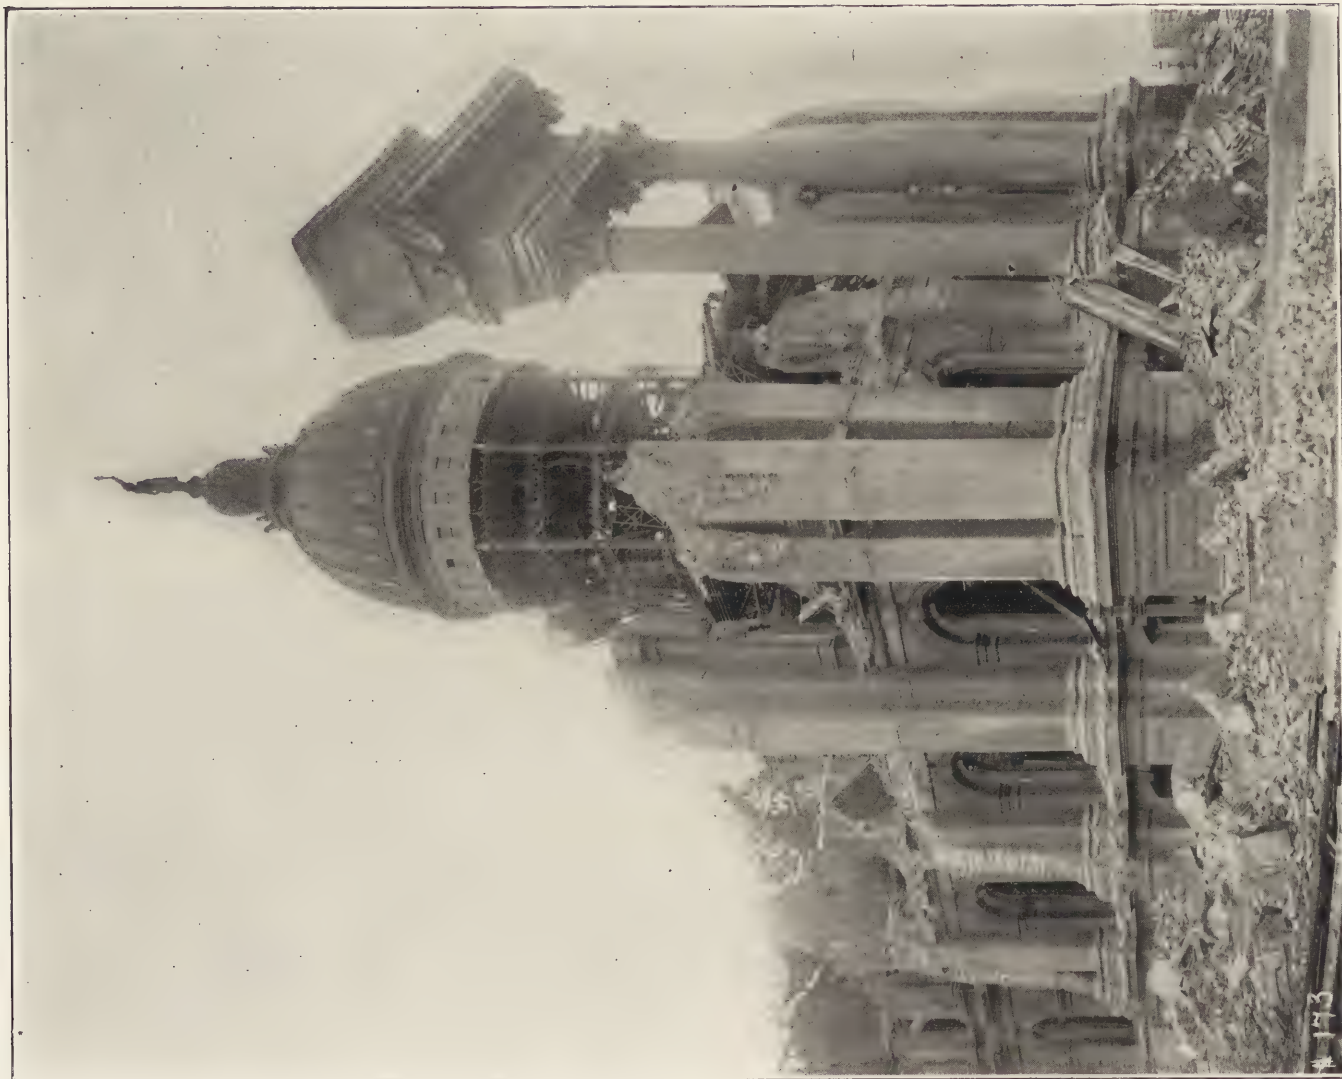
CITY HALL. McAllister, Larkin and Leavenworth Streets. Showing the southwest corner. A large entablature supported by two columns is isolated from the rest of the building and remains standing. The entire upper portion of the heavy brick walls of this part of the building was overthrown, sections weighing as much as several tons remaining intact on the ground below. A mass of tangled steel framing which originally supported the roof is at the left-hand side. Practically all the mason work of the tower was shaken out.

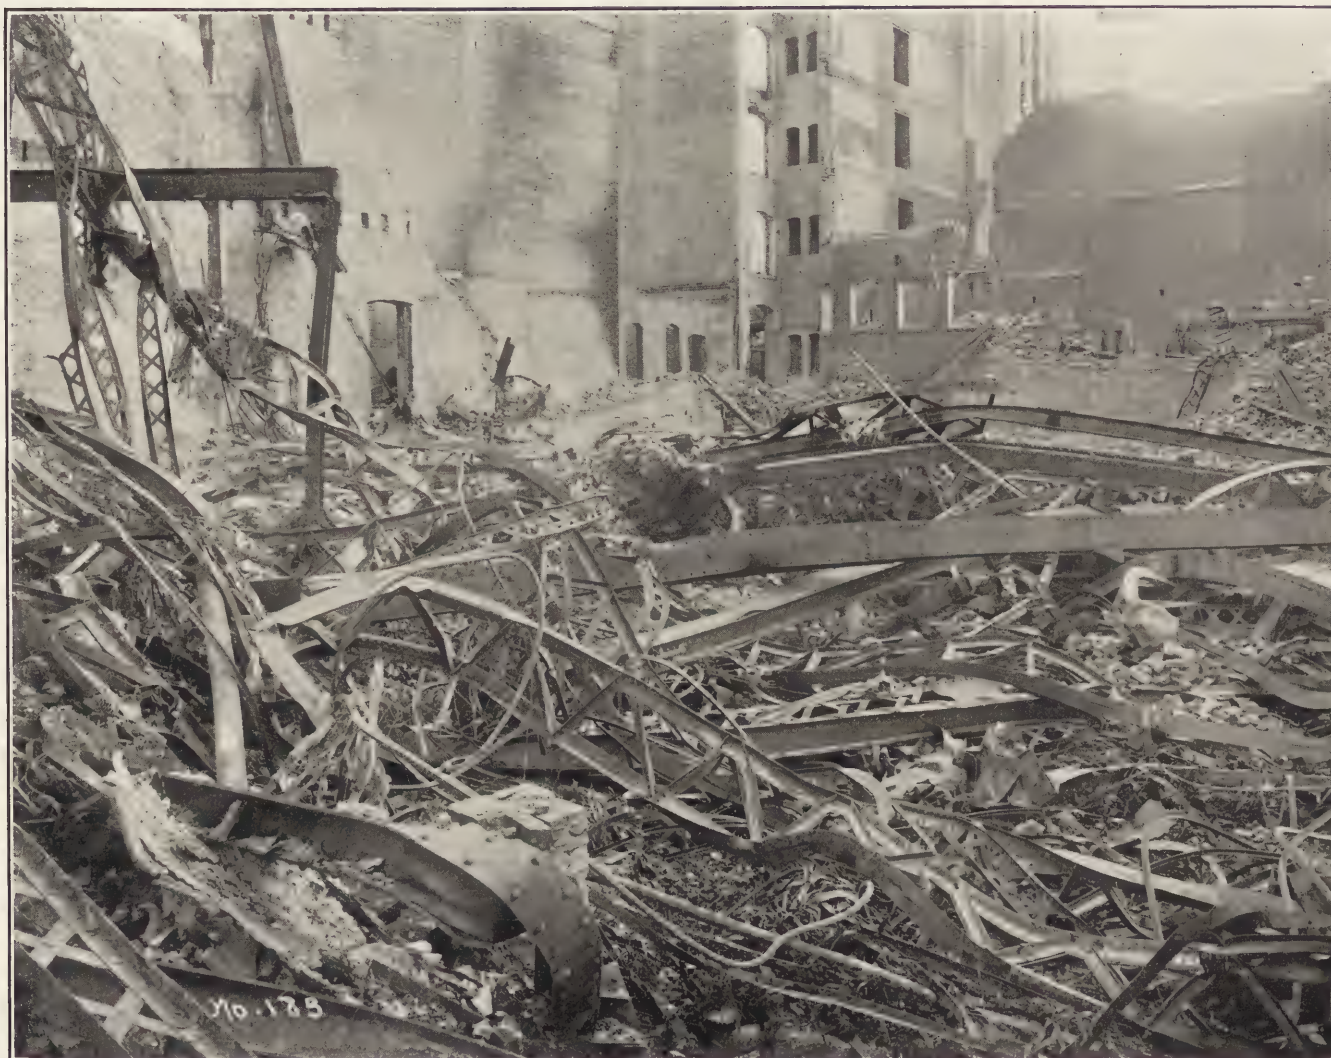
TIVOLI OPERA HOUSE. Showing the ruins of the auditorium and stage portions, which were of non-fire-proof construction. The floors and finish were of wood, the floor loads being carried on steel framing and bearing walls. In these ruins were evidences of the hottest fire noted in the burned district. Expanded metal lath was incinerated. Latticed angle column sections and light trusses were blistered and burned so that they parted, $\frac{1}{4}$ " metal being reduced at the fractures to the thickness of ordinary pasteboard. The three-story entrance portion of the building is of fire-proof construction and remains standing.

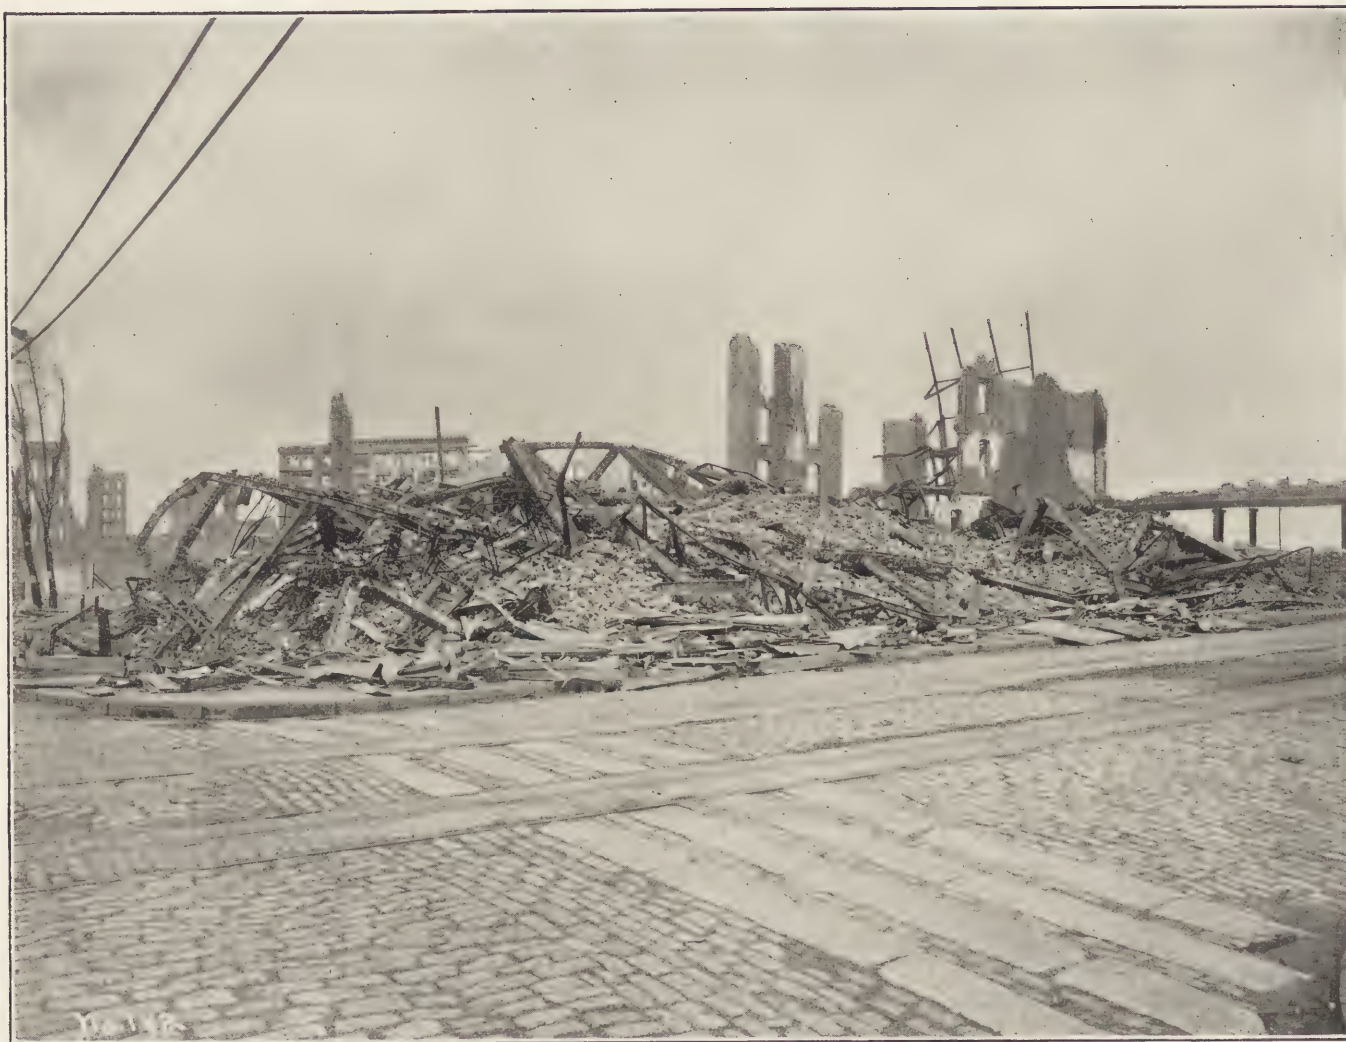
LINDA VISTA APARTMENT HOUSE. Southeast Corner Turk and Jones Streets. Showing the total destruction of a nine-story, steel skeleton, fireproof building by dynamite. This building withstood the earthquake without damage, and was dynamited by the authorities when the fire threatened this section of the city. The Roebling cinder concrete floors were of the flat slab type, and the partitions were of Roebling wire lath and plaster, finishing 2" in thickness. The fire subsequently consumed all that was combustible in the *débris*.

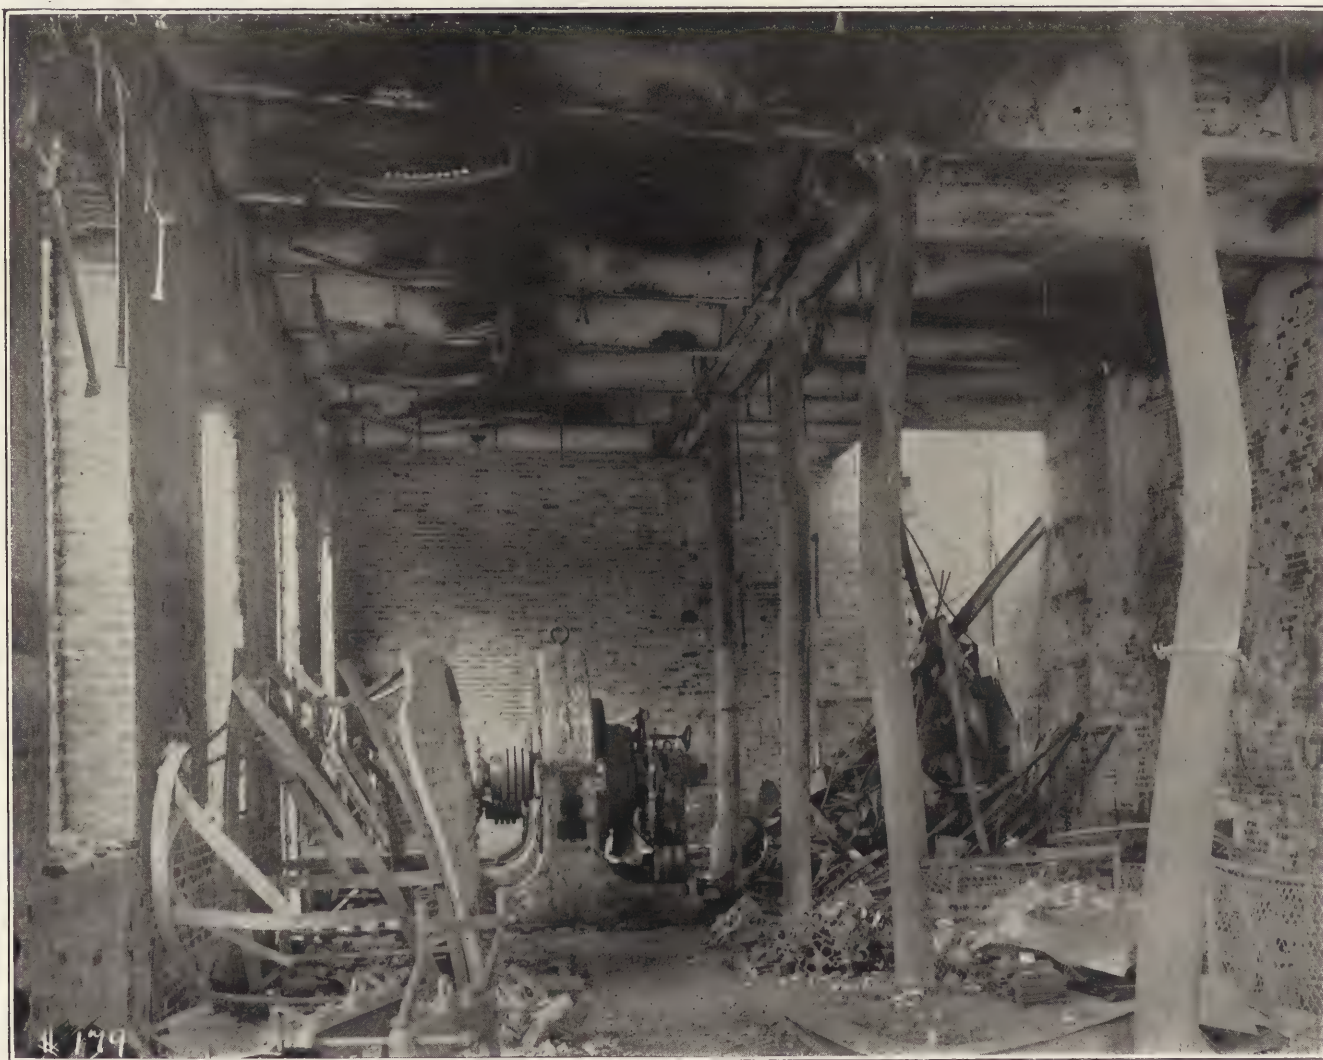
EIGHTH STREET SUB-STATION of the San Francisco Gas and Electric Co. First Story. Showing the condition of the unprotected cast-iron columns, switch boards, machinery, etc. The segmental stone concrete arches of the second floor remain in good condition. This view is typical of two other similar buildings owned by the same company in other parts of the city.

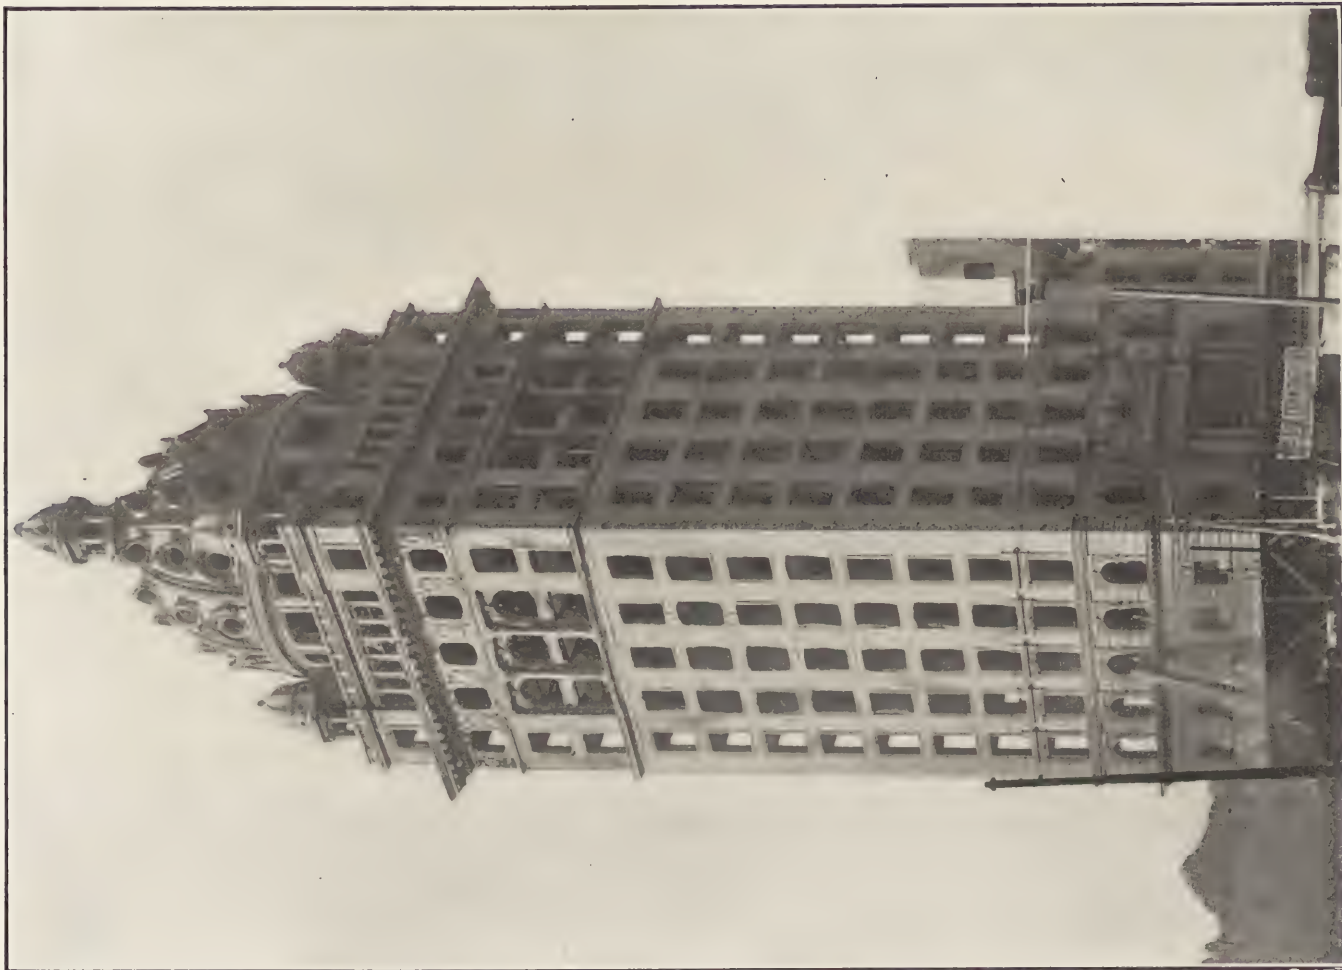
CLAUS SPRECKELS (OR CALL) BUILDING. S. W. Cor. Third & Market Sts. The façades are of Colusa sandstone. The entire Third St. front is badly scaled and spalled by the fire. The south front is also similarly damaged, but in a lesser degree. The Market St. front is in good condition, only a few window openings being damaged. The west front, while considerably more damaged than the Market St. side, can be repaired. The foundations remain level, and the walls plumb. The steel skeleton frame is uninjured. The concrete floors throughout are in first-class condition. The hollow tile partitions, column covering and wall furring have been greatly damaged and are in bad condition. This is the tallest and most celebrated building in San Francisco, and is structurally uninjured.

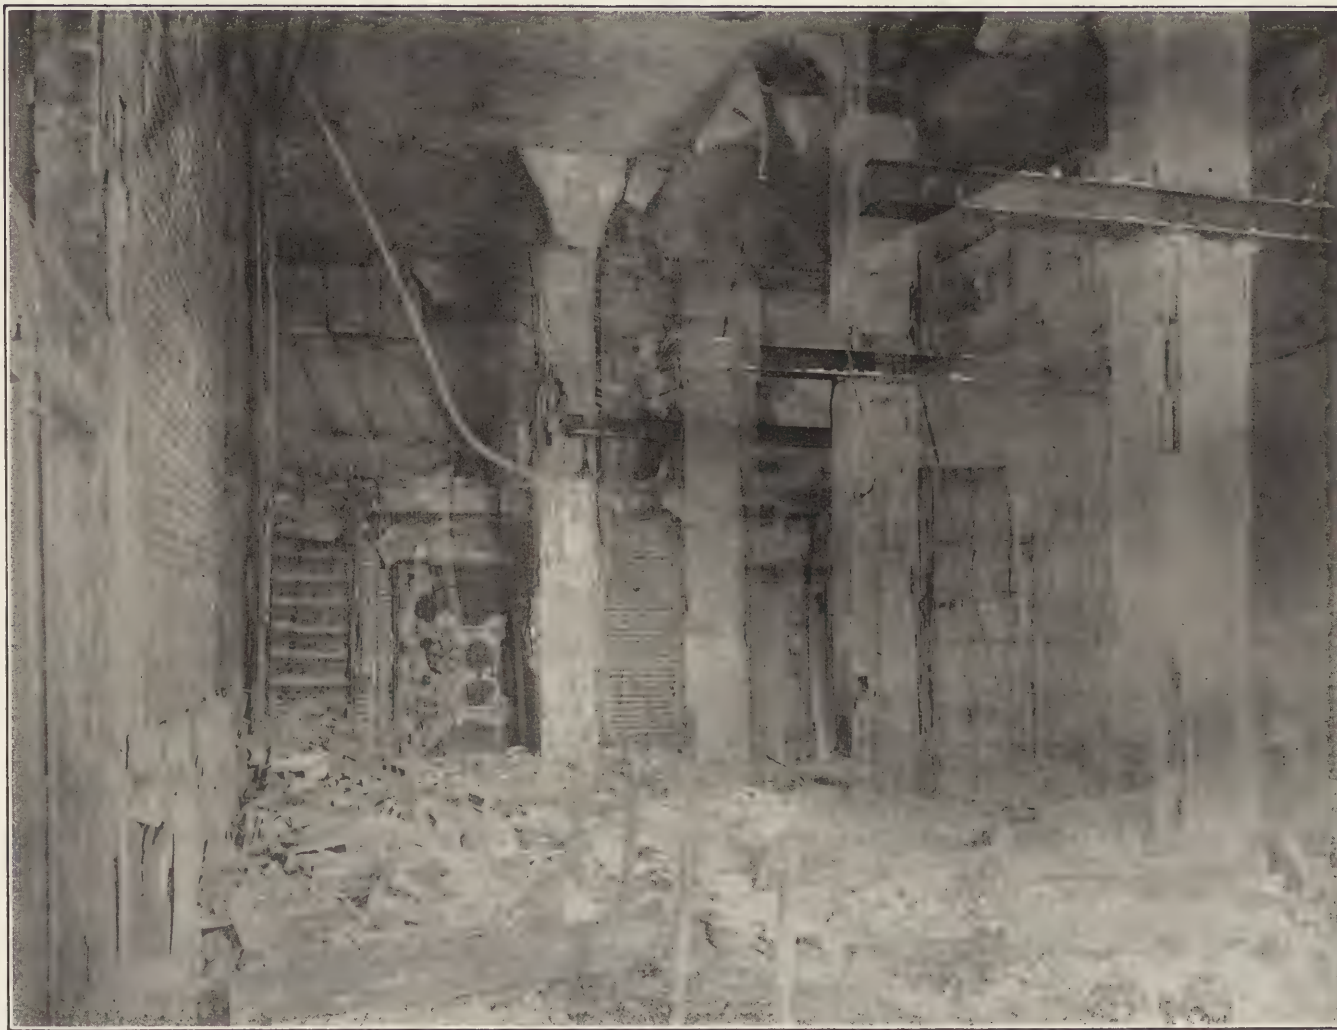
CLAUS SPRECKELS BUILDING. First Story. Showing the damage to the hollow tile wall furring, column covering, hollow wire lath partitions and wire lath ceiling. Note the hollow tile *débris* on the stairway at the left. The stairways in this building were totally wrecked by hollow tile and other *débris*. The concrete floors are in first class condition throughout.

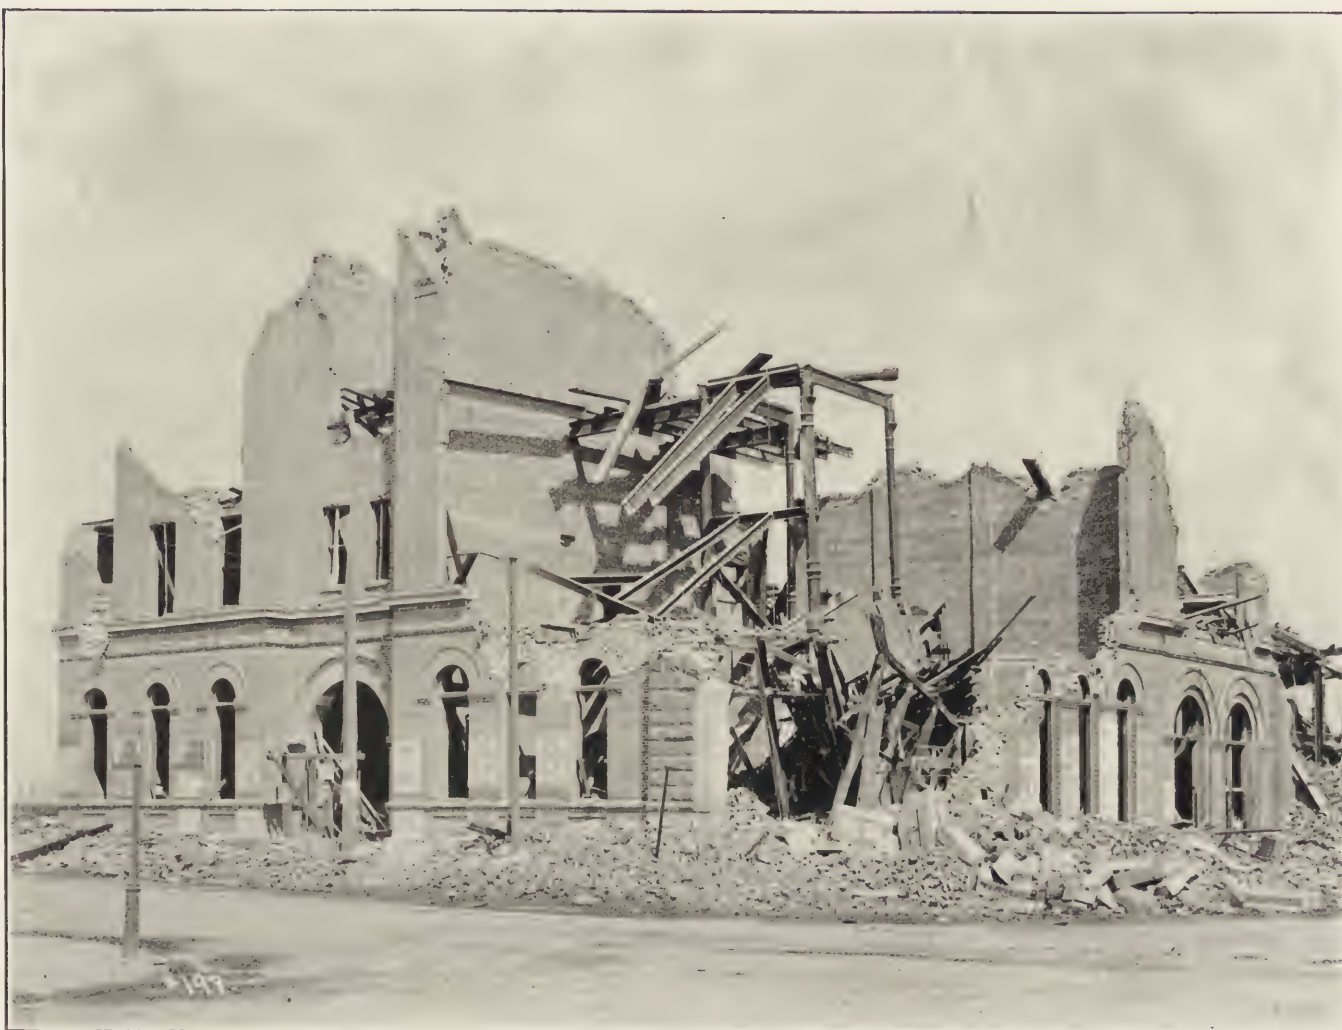
JACKSON BREWERY. Northwest Corner of Eleventh and Folsom Streets. This building was in the course of construction and was totally wrecked by the earthquake. Lime mortar of poor quality was used. All the walls were bearing walls and were not tied together. Fire did not enter the corner of the building shown in the foreground, but consumed everything combustible in the rear. Note the five beams at the third story level projecting toward the rear which carry a load of brickwork on planking, with no other support than the angle connections to the girder at one end.

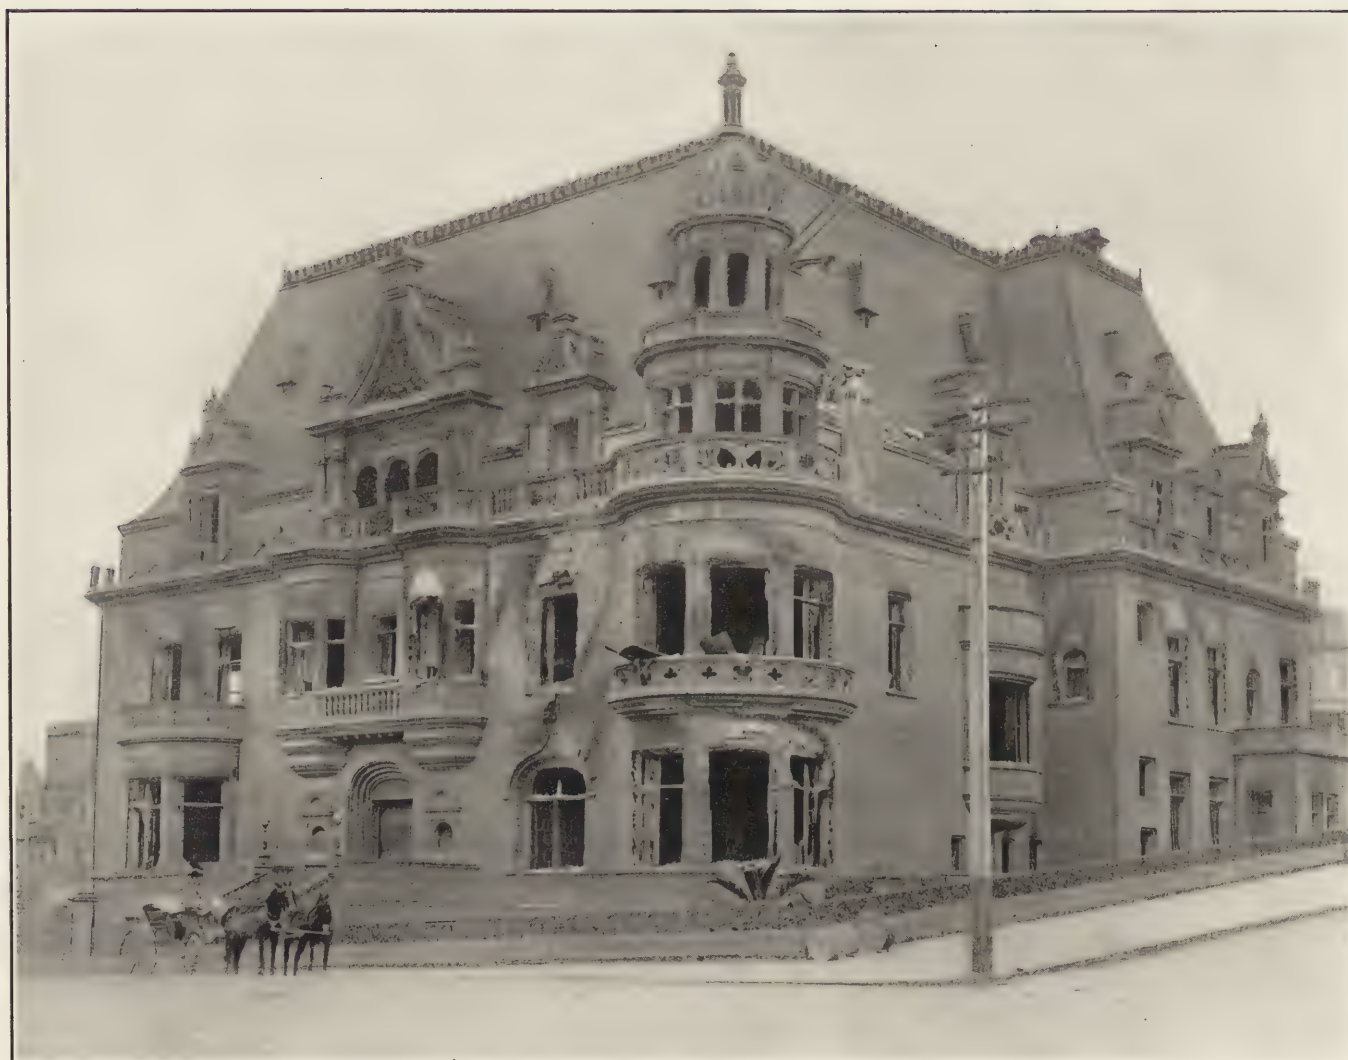
CLAUS SPRECKELS RESIDENCE. Southwest Corner Clay Street and Van Ness Avenue. The façades of brown stone are badly spalled around the window openings. The earthquake damage to the walls is slight. This was the only fire-proof residence in the burned district.

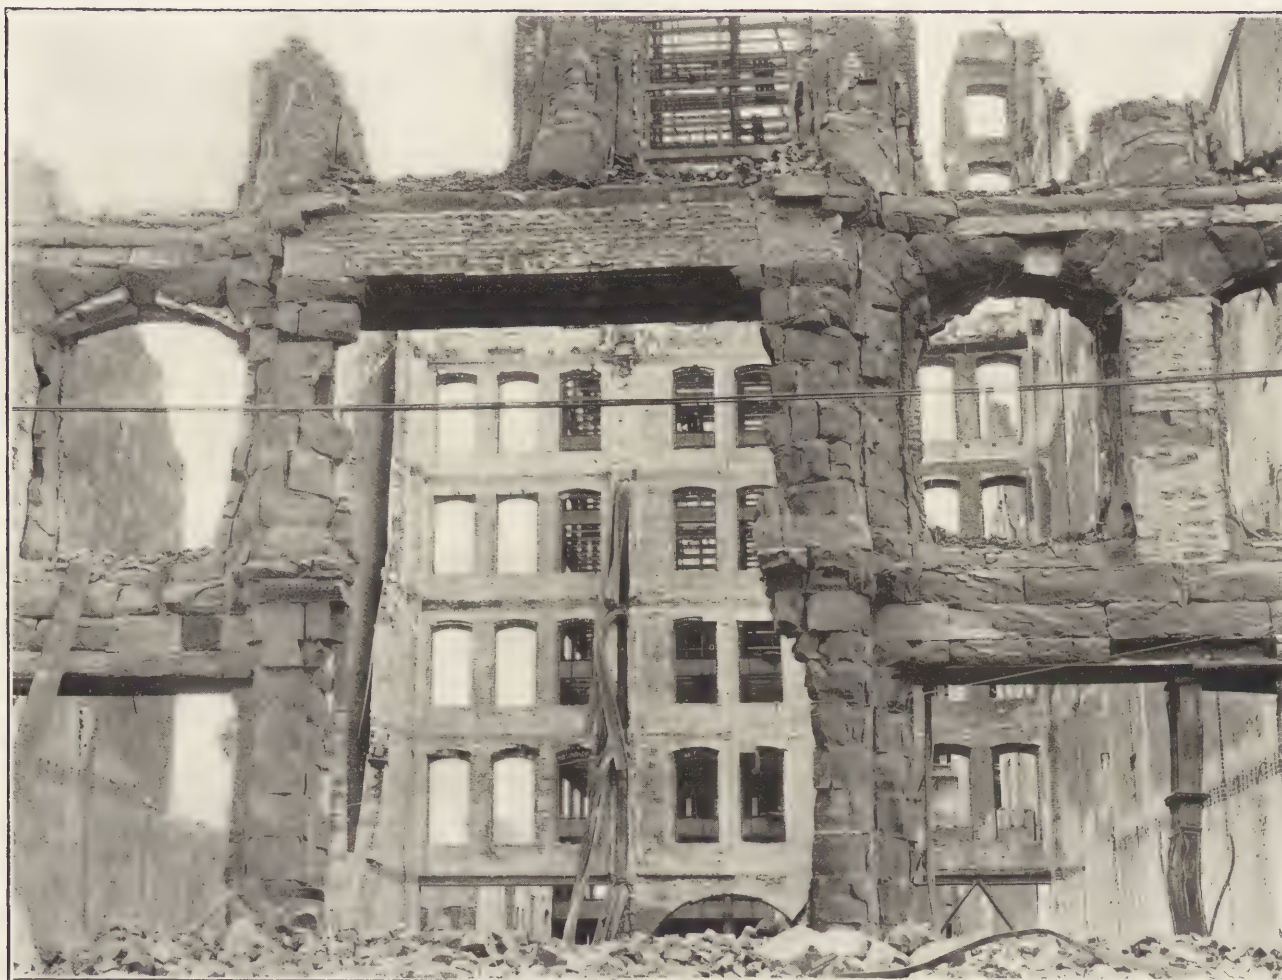
SPALLED GRAY SANDSTONE. South side of Post Street, between Stockton Street and Grant Avenue. Showing a portion of the front of the Friedman Furniture Store.

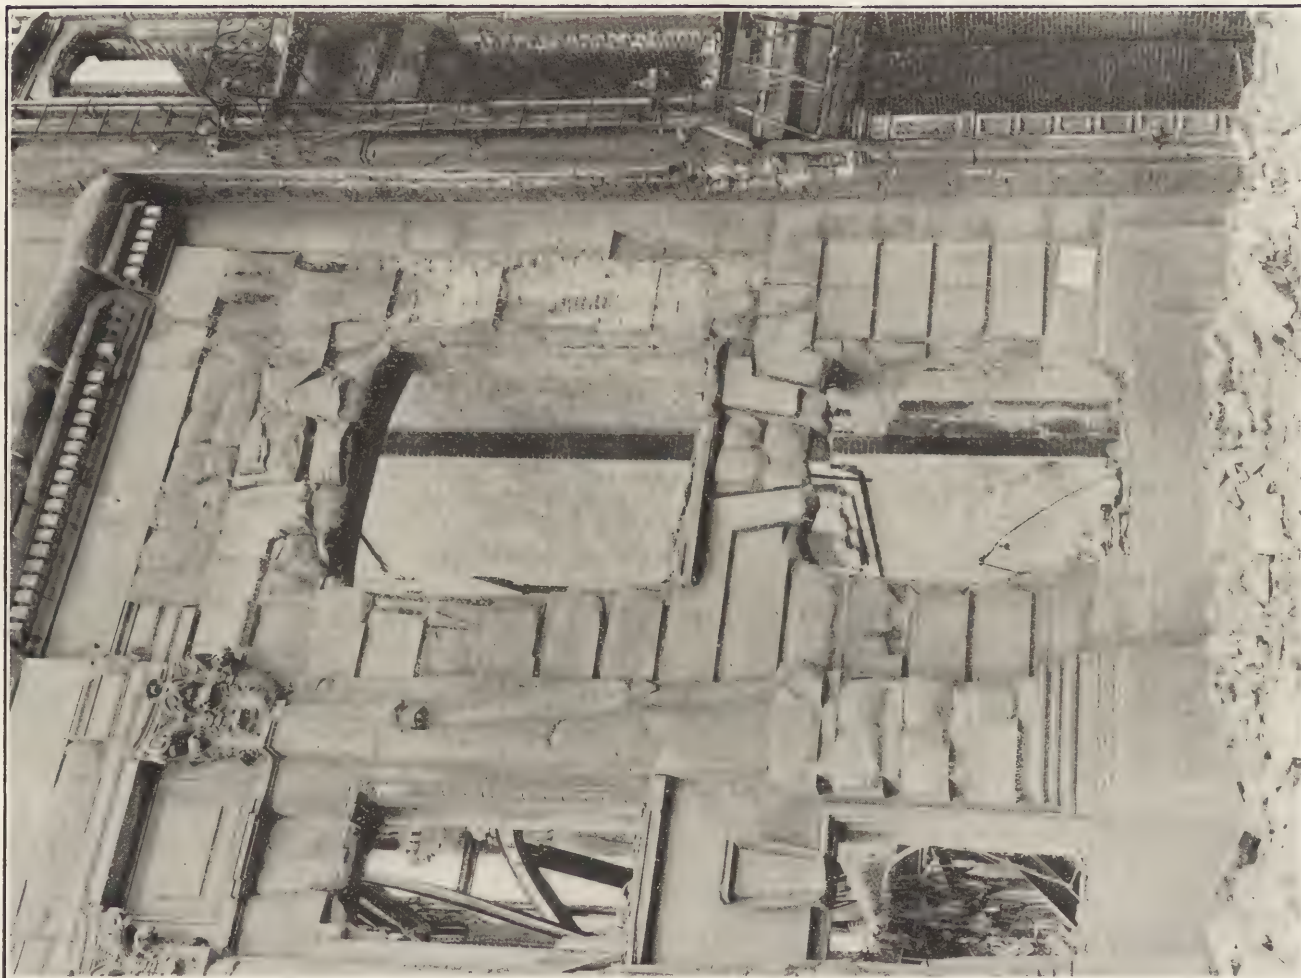
SPALLED RED SANDSTONE. Northeast Corner Post and Stockton Streets.
Showing a portion of the Pacific Union Club's new building.

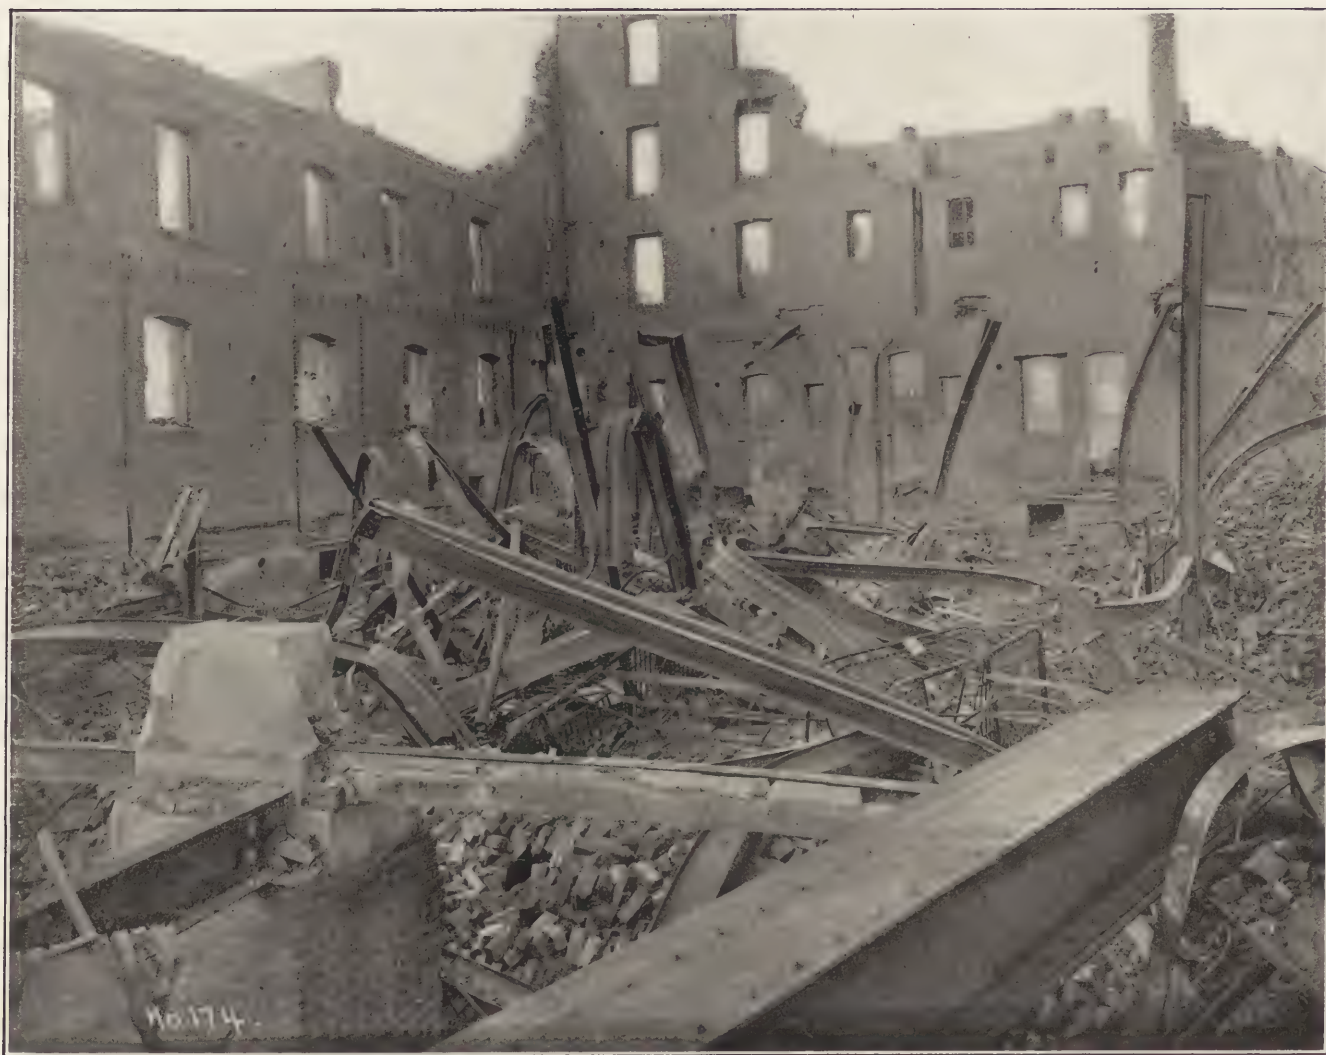
RUINS OF A CLASS B BUILDING. East Side of Third Street south of Mission Street. Showing the typical condition of buildings with wood floors supported by unprotected steel framing and bearing walls. Also showing a badly spalled granite column base.
